MERRIMACK RIVER BASIN  
FITCHBURG, MASSACHUSETTS

SNOWS MILL POND DAM  
MA 00878

PHASE I INSPECTION REPORT  
NATIONAL DAM INSPECTION PROGRAM

FEBRUARY 1979

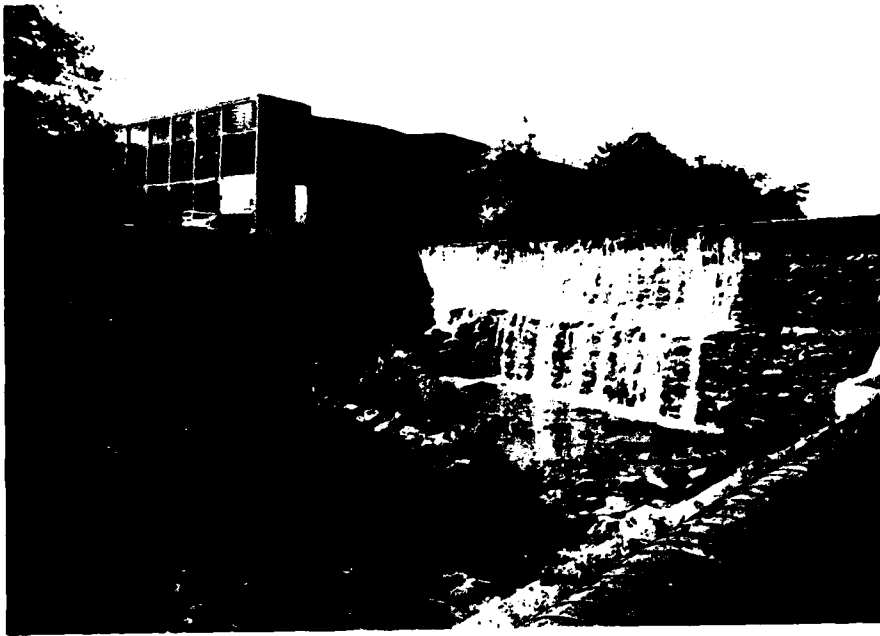
1. Overview of Snows Mill Pond Dam, spillway  
portion (October 1978)

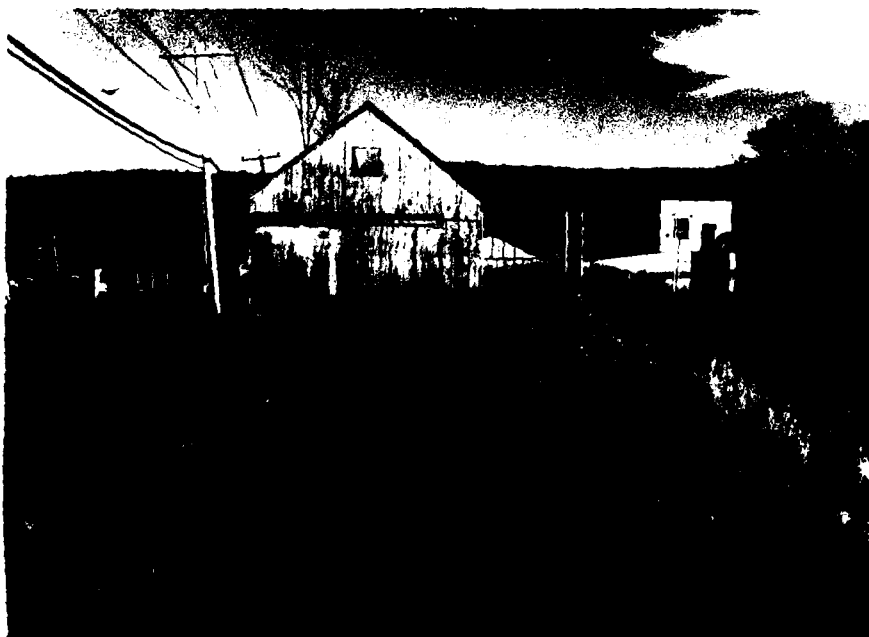
1. The embankment crest and slopes, Photos No. 2 and 3, are generally grass-covered. Some low brush growth and local areas of minor surface erosion were noted on the upstream slope.
2. The stone masonry walls supporting a portion of the downstream face of the dike embankment are generally in good condition, Photo No. 4. Clear running water was noted seeping under the lower stone wall at the location of Photo No. 5. The rate of flow was estimated at 1/2 gpm, causing the surrounding area to be soft and wet. No indication of piping was observed.

3. Earth dike crest from left abutment

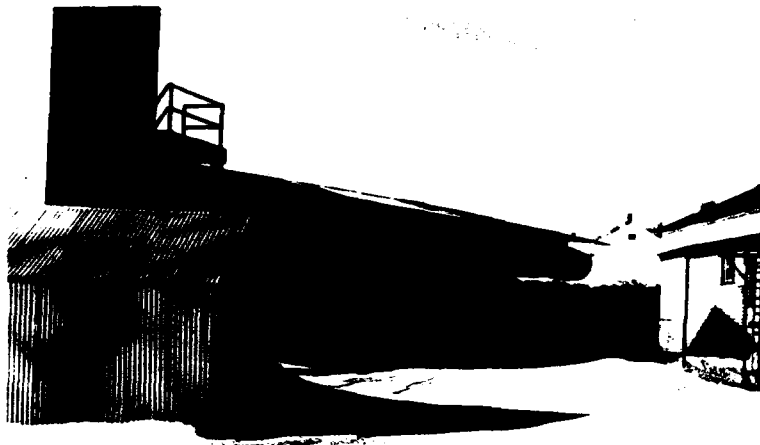
4. Stone masonry walls on downstream side of earth embankment (February 1979)

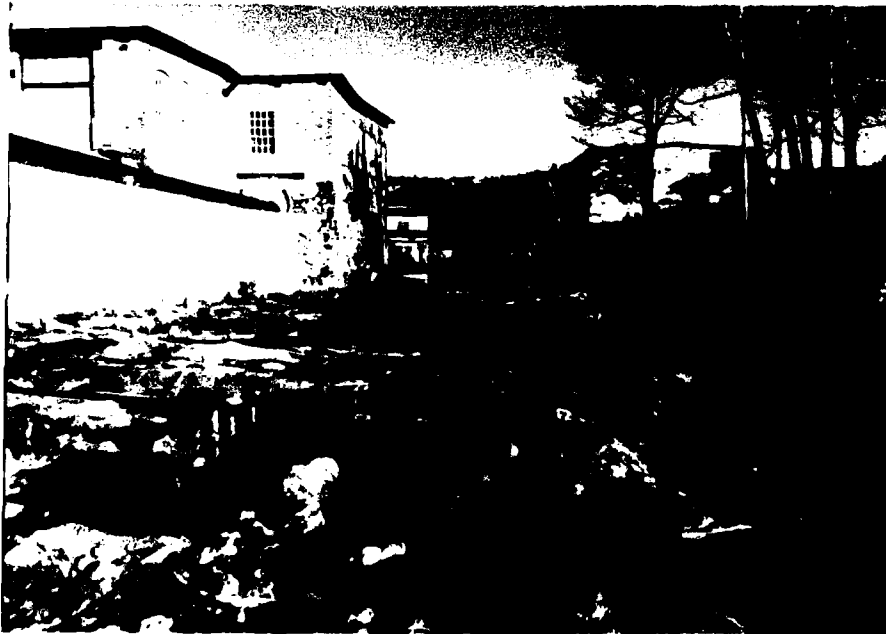
17. View downstream from dam showing exposed bedrock and boulders in channel
